## MILESTONE INSPECTION REPORT

**IMPERIAL POINT #6**

**CONDOMINIUM**

**10216 REGAL DRIVE**

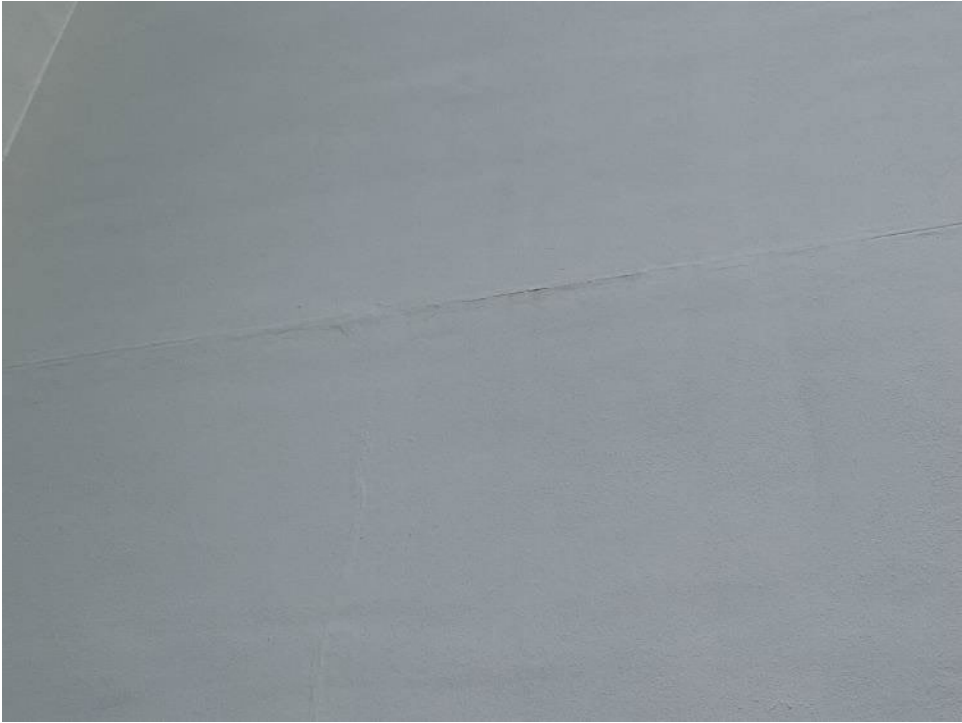
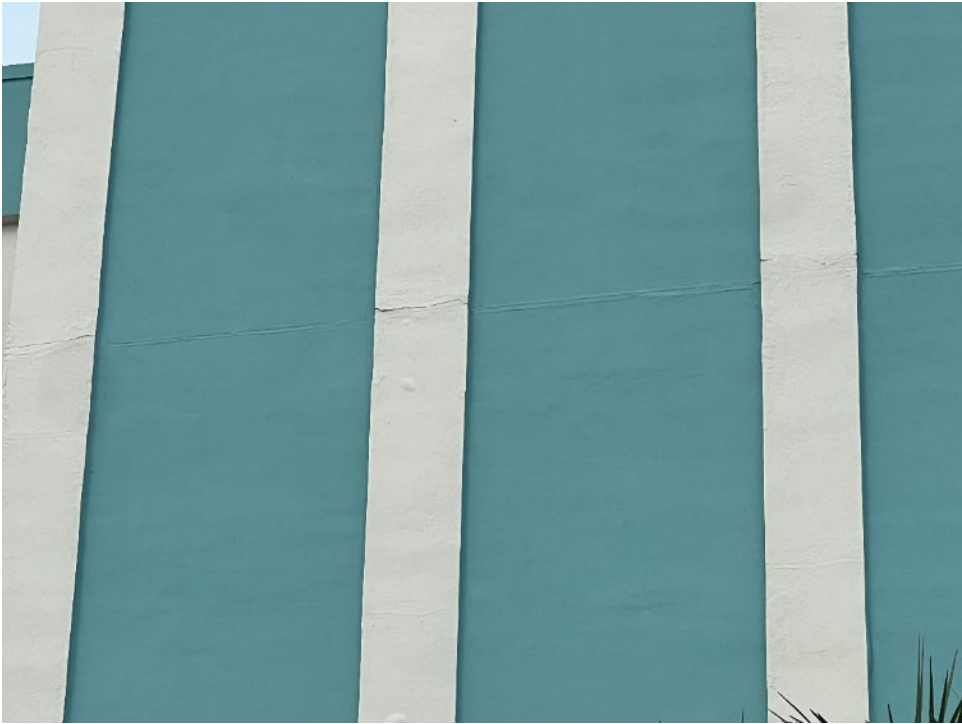
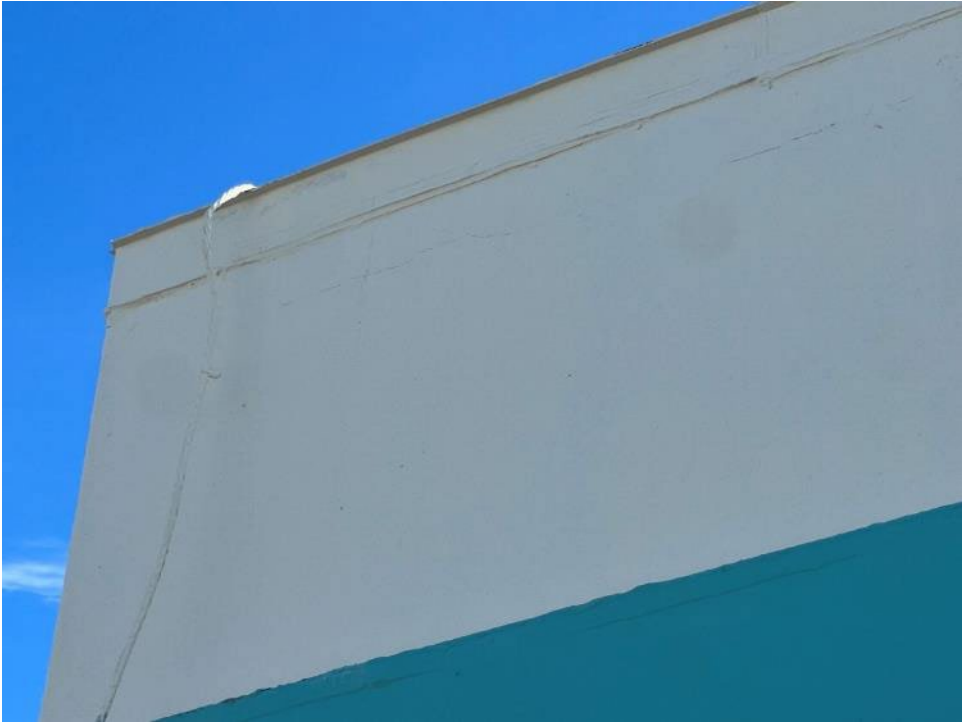
- Exterior wall cracks were observed at exterior CMU wall to reinforced concrete slab transitions on the east and west elevations with portions previously sealed, which is expected for a structure of this age and construction type (Refer to Figure E-5 through Figure E-7).

- Repair any existing exterior wall cracks via routing and sealing with a urethane sealant along the building exterior elevations.
- Regular maintenance of the exterior building paint coating. While not required by the building code, “best practices” for longevity of exterior building paint coatings is recommended to be recoated every 7 years.
- Repair any areas of surface corrosion on rooftop metal access stair structural steel framing components and guardrails/handrails exhibiting section loss. It should be noted

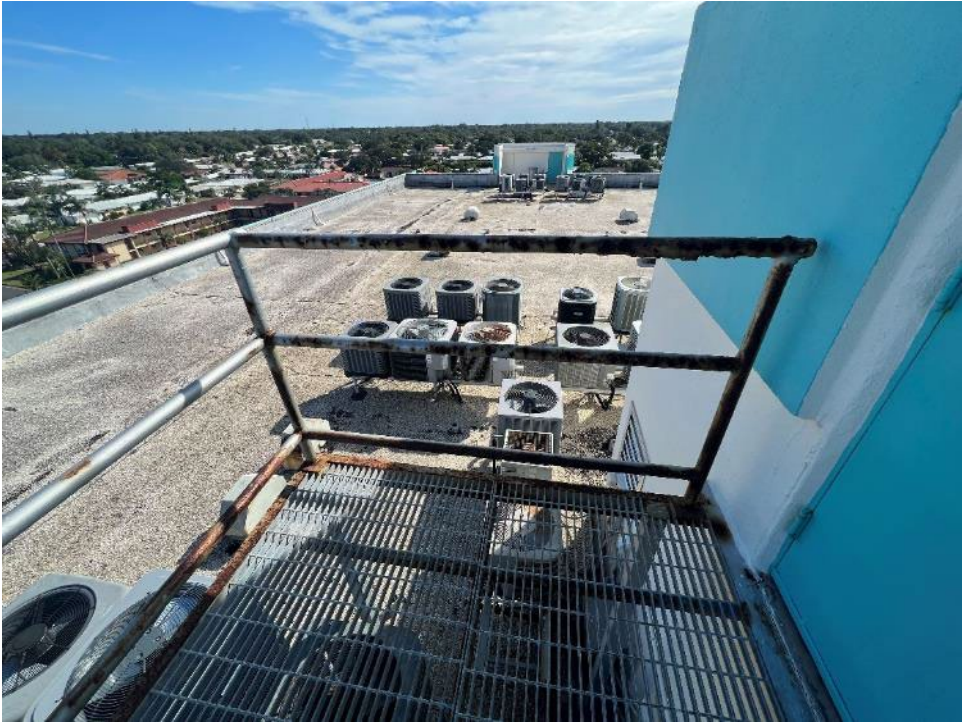
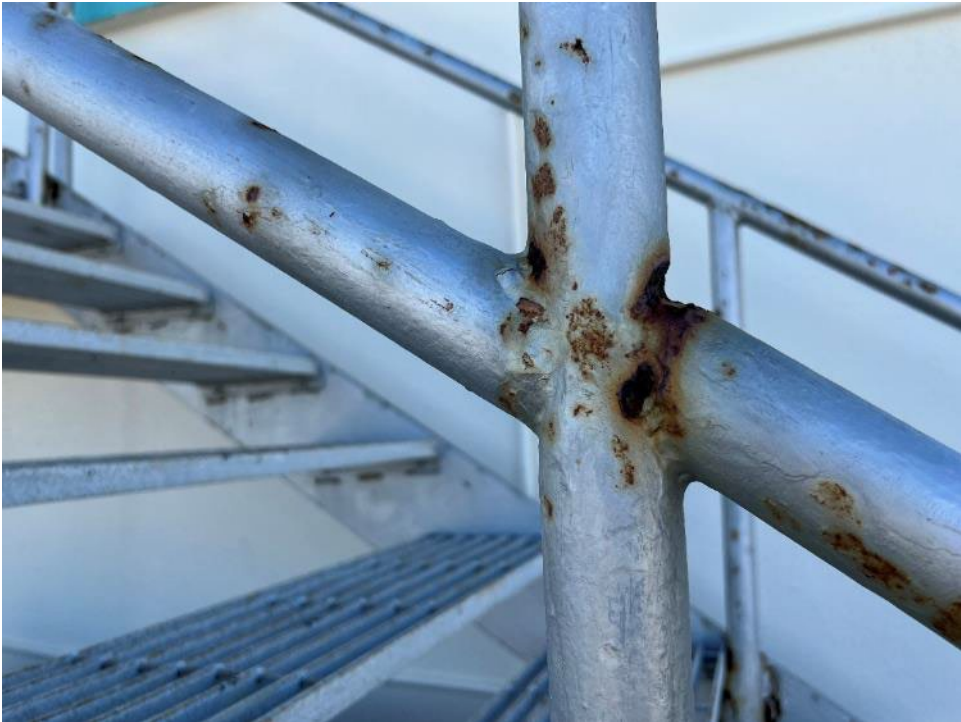
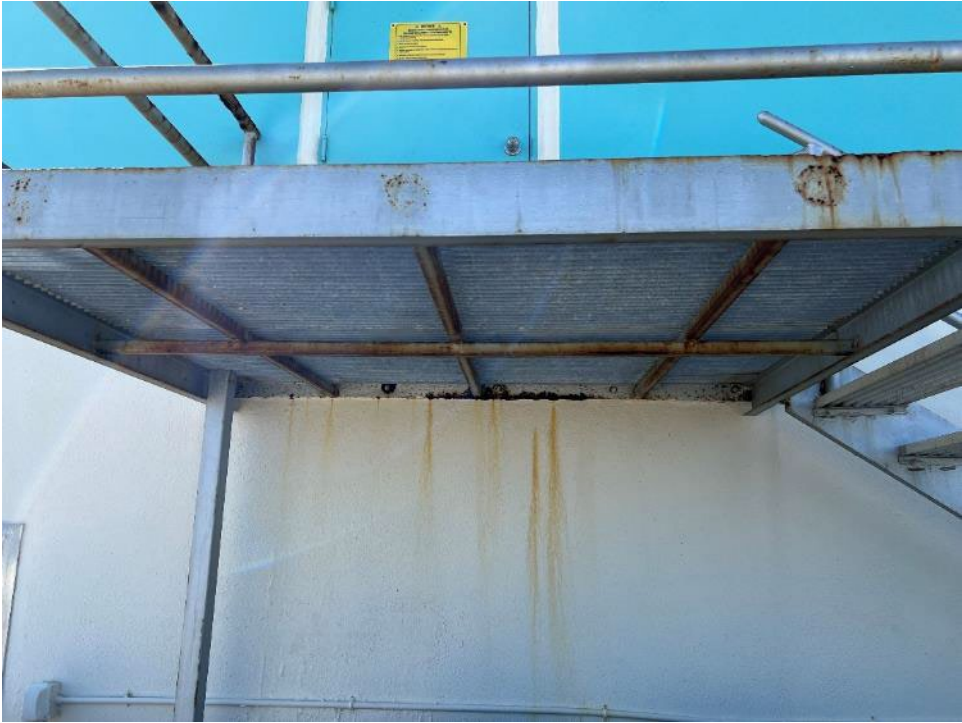
- Areas of surface corrosion to metal guardrail and framing components were observed at rooftop metal access stairs to mechanical room with portions exhibiting section loss (Refer to Figure E-9 through Figure E-11). Access to areas of metal guardrails exhibiting section loss should be limited until repairs are made and/or guardrails are replaced.

that due to the extent of metal guardrail repairs it may not be feasible to just repair areas exhibiting section and replacement of all the metal guardrail components may need to be considered.

- Surface preparation and application of exterior paint coatings on rooftop metal access stair structural steel framing components and guardrails/handrails including treating areas of surface corrosion. While not required by the building code, “best practices” for longevity of exterior building paint coatings is recommended to be recoated every 7 years, however the existing surface corrosion should be monitored and may need to be addressed more frequently as preventative maintenance. Elevated Engineering would also recommend being proactive and planning for replacement of the metal stair components in the future as addressing areas of surface corrosion will be an ongoing maintenance item that will become no longer feasible in the future and replacement will need to be considered. Please note the areas surface corrosion observed do not currently appear to represent a serious structural condition, however if left unaddressed these areas will likely worsen and may develop into a more serious structural condition.

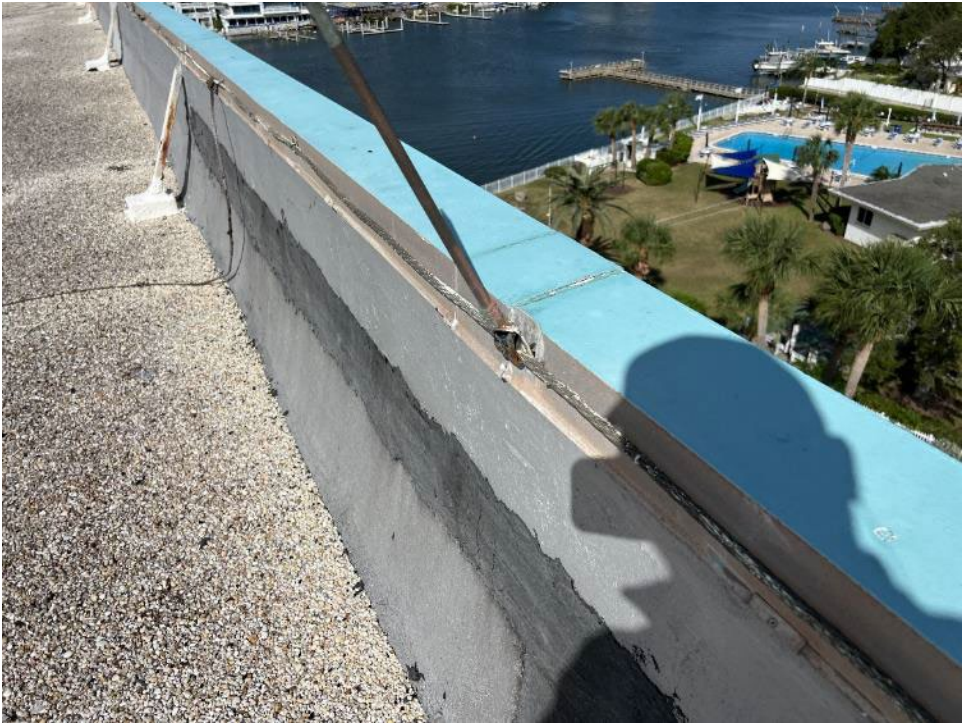
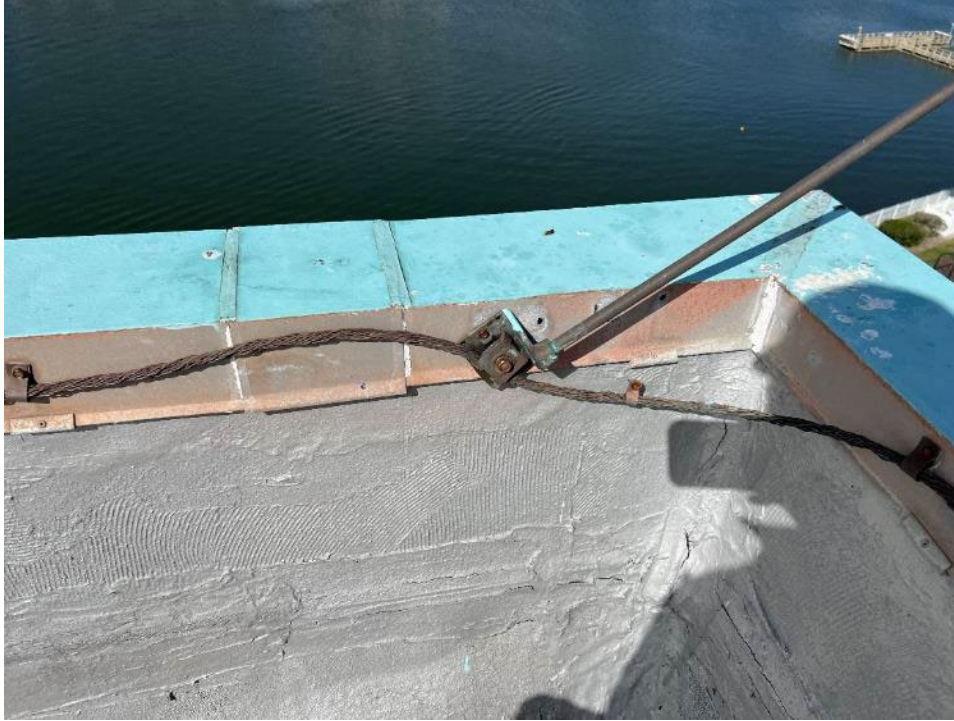
- Multiple loose and/or disconnected lightning rod connections were observed in the lightning protection system along the interior perimeter of the roof parapet wall (Refer to Figure E-12 and Figure E-13).

- Repair loose and/or disconnected lightning rod connections in the lightning protection system along the interior perimeter of the roof parapet wall.
- Regular maintenance of the roofing system. Please note maintenance of roofing systems is typically dependent on the age and effectiveness of the roofing system, which is outside of the intent of the Milestone Inspection as Elevated Engineering understands it and therefore no comments on the recommended maintenance of the roofing system is included.

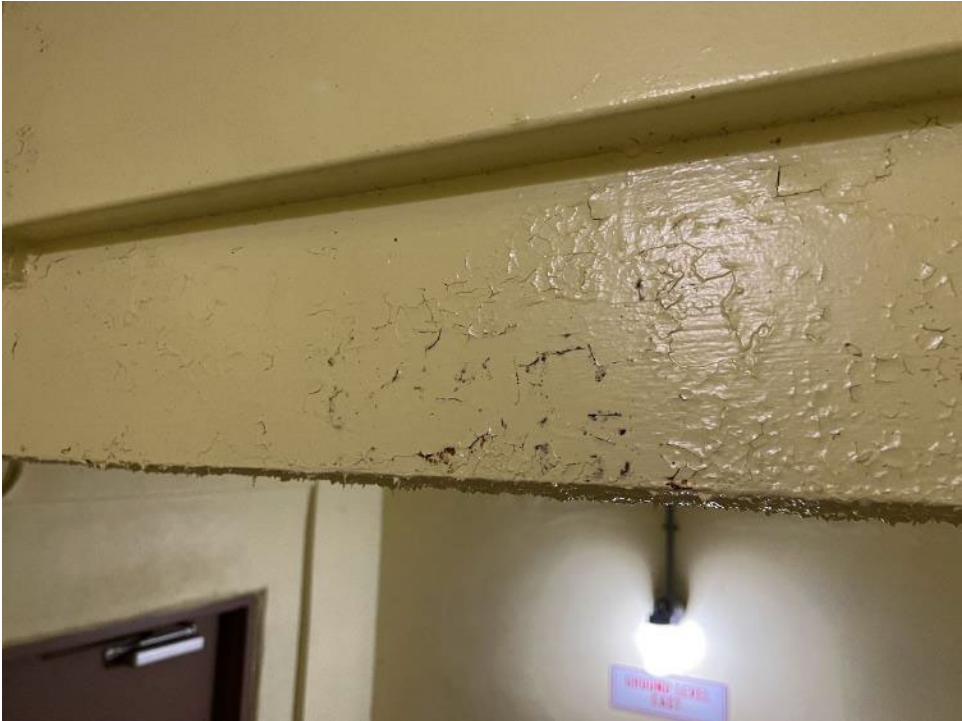
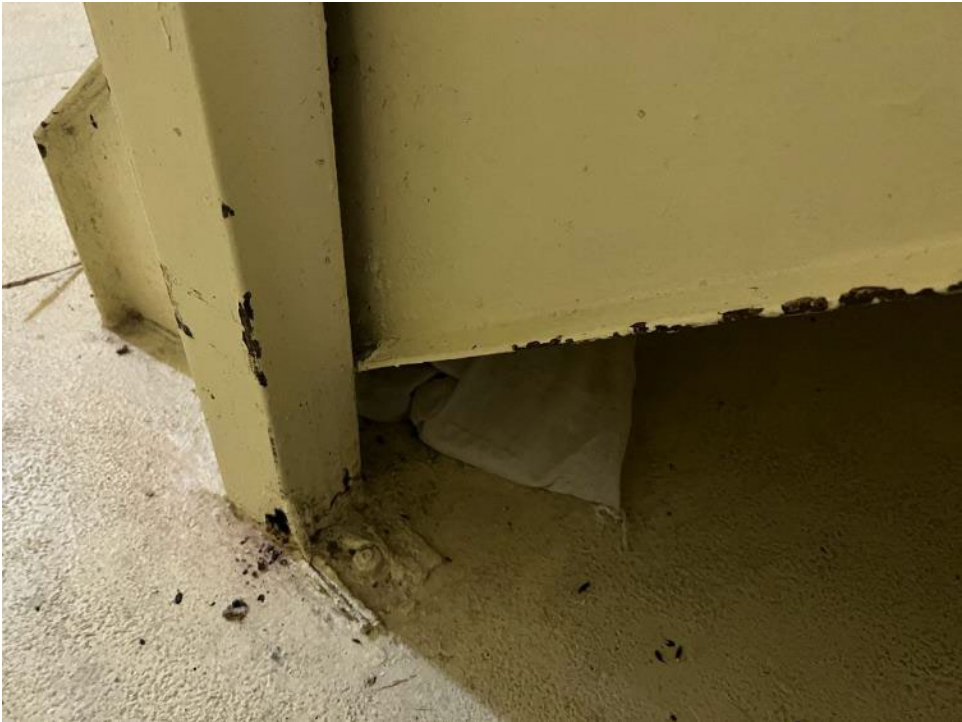
- Localized areas of peeling paint and/or surface corrosion were observed along metal pan and steel framing components (Refer to Figure S-7 and Figure S-8).

- Regular maintenance of the stair floor coatings. Maintenance of floor coating is dependent on floor coating product manufacturer's specifications/recommendations.
- Regular maintenance of the exterior paint coatings on structural steel framing components, metal pan stairs, and guardrails/handrails including treating areas of surface corrosion. While not required by the building code, "best practices" for longevity of exterior building paint coatings is recommended to be recoated every 7 years. Please note the areas surface corrosion observed do not currently appear to represent a serious structural condition, however if left unaddressed these areas will likely worsen and may develop into a more serious structural condition.

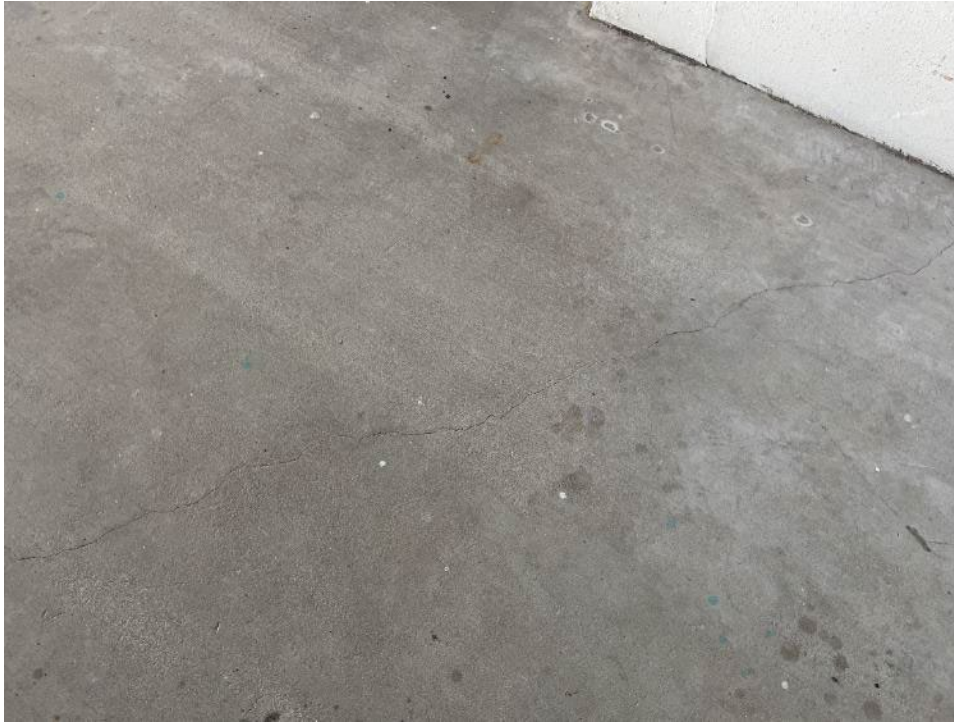
Figure P- 9

- The 1<sup>st</sup> floor parking garage is shown in Figure P-1 and Figure P-2.
- The 1<sup>st</sup> floor parking garage appears to be constructed of reinforced concrete columns, masonry infill walls, and reinforced concrete slab-on-grade components.
- Multiple areas of delaminated exterior stucco finishes and/or concrete spalls were observed along the concrete columns (Refer to Figure P-3 through Figure P-8).
- Multiple cracks were observed in the concrete slab-on-grade components, which is expected for a building component of this age and construction type (Refer to Figure P-9).

- Repair existing areas of unsound concrete and concrete spalls along the concrete columns. Currently this condition does not appear to represent a serious structural condition, however, concrete spalls need to be addressed as once concrete spalling starts the rate of additional corrosion increases rapidly, which leads to further concrete deterioration, which may develop into a more serious structural condition.
- Repair existing areas of delaminated, cracked and/or spalled exterior stucco finishes along the concrete column surfaces. Currently this condition does not appear to represent a serious structural condition, however if left unaddressed these areas will likely worsen and may develop into a more serious structural condition.
